**Office of Public Works
Pretreatment Program**
316 North Park Avenue
Helena, MT 59623

INDUSTRIAL WASTE INITIAL INSPECTION FORM

Business Name: Blue Collar Diesel

INDUSTRIAL WASTE INITIAL INSPECTION PHOTO LOG

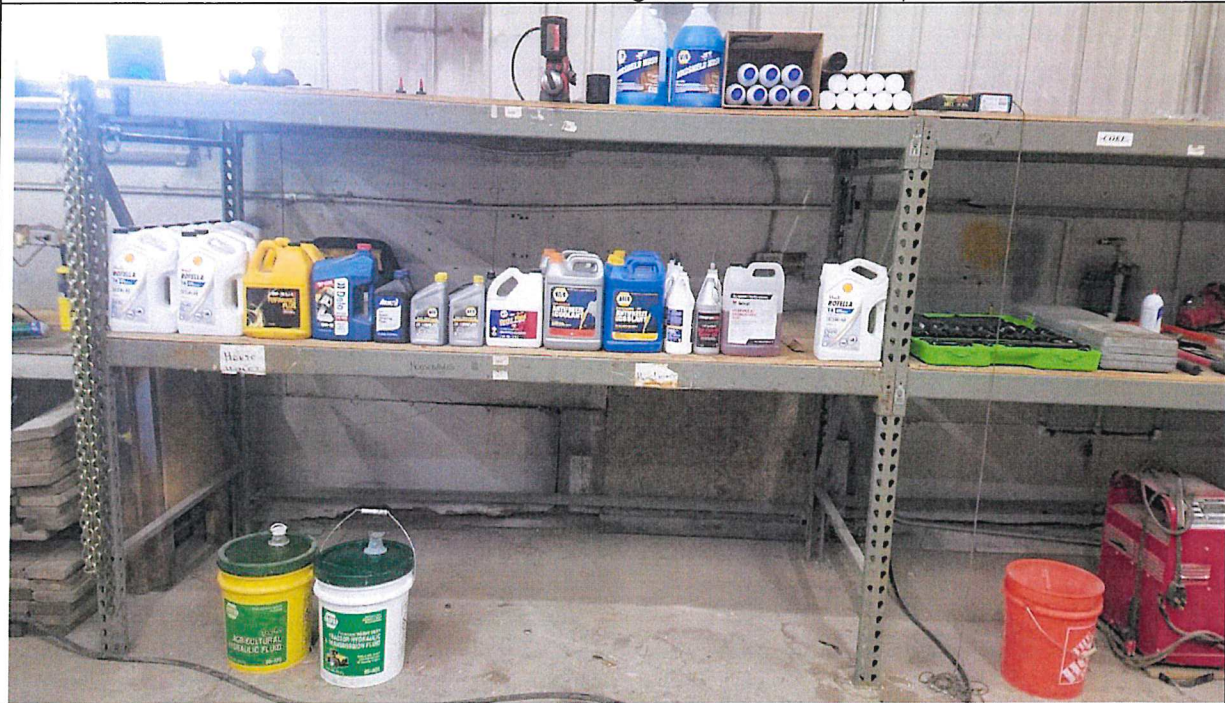
Photo 1: View of the main automotive fluid storage area for the facility.

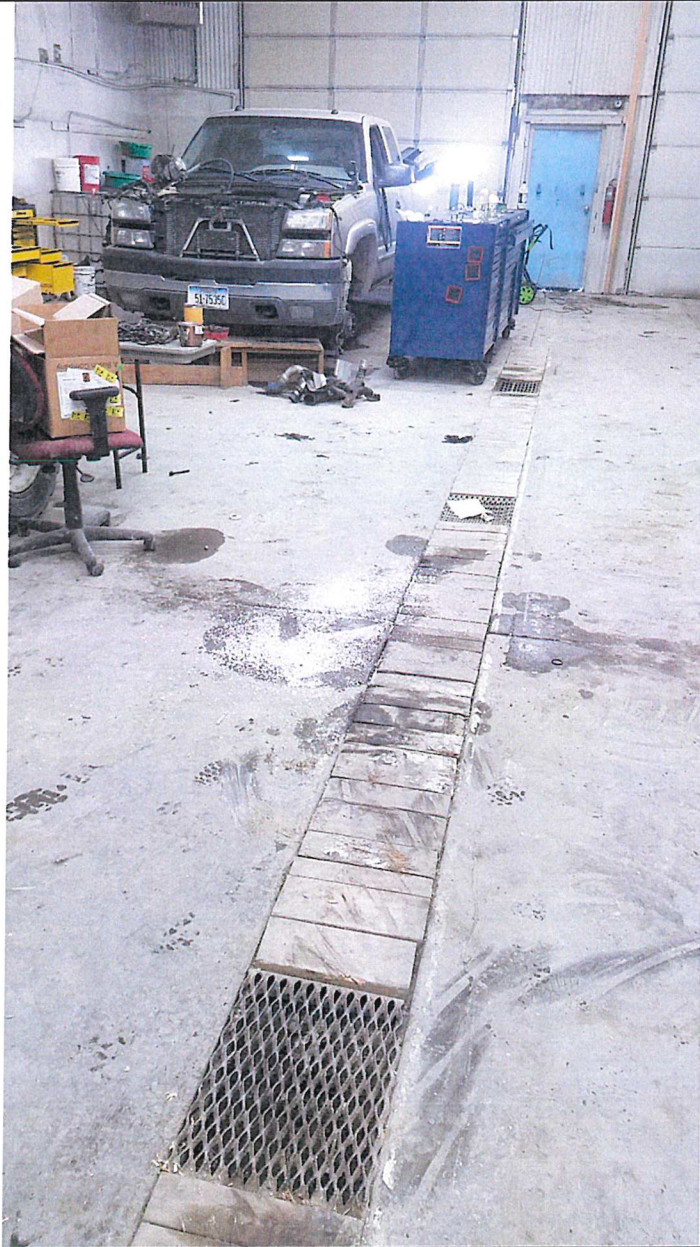
Evidence of spills on site:	Small engine oil drips on shop floor. Most covered and contained with floor dry.
Location of floor drains in storage or use area:	Down the center of the shop and in the vehicle inspection pit under main repair area located in the South East bay.
Spill containment description:	Spills contained in the building. Concrete floor with a sump. Most chemicals are small quantities.
Outside chemicals storage area description:	N/A
Spill path and potential to sanitary sewer or storm sewer description:	No local outside drains to municipal storm water system or POTW.
Notes:	No storm sewer on the premises. Small quantities kept on hand. Drain on site does not discharge directly to sanitary sewer must go through sand interceptor.

Photo 2: View looking east down the main shop area. Drain is visible going down the middle of the shop.

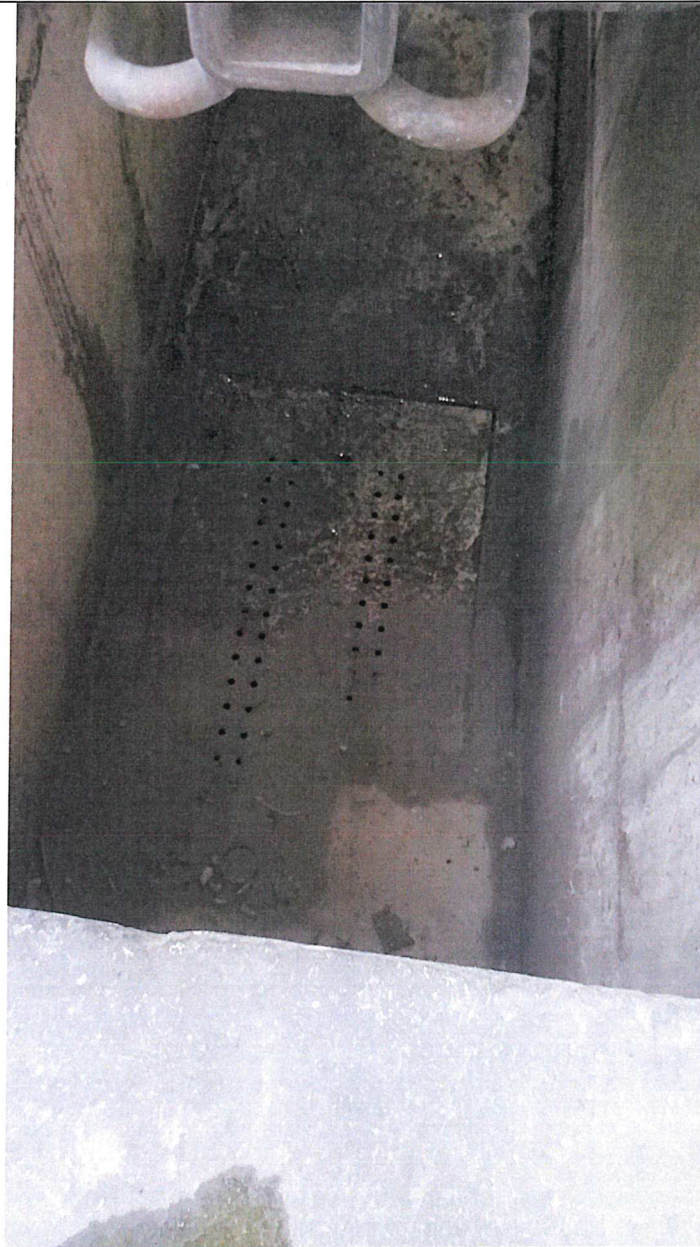
Photo 3: View of sump at the bottom of the shop's automotive pit.

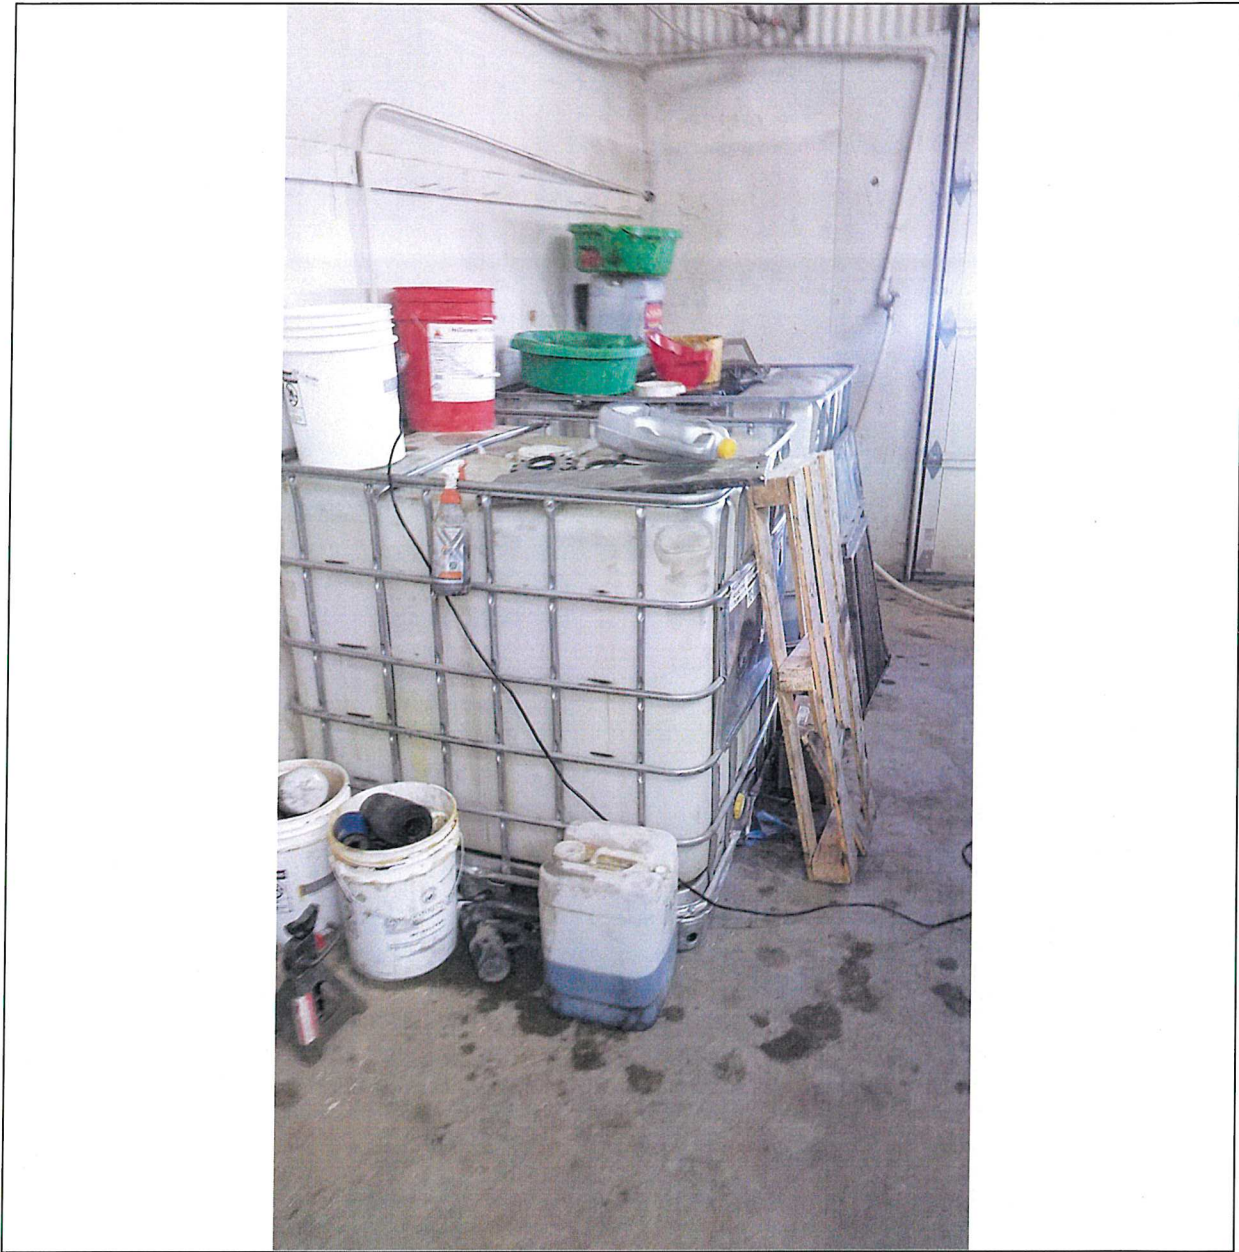
Storage container (AST, UST, drum, tote, etc), number present, and size:	275 gallon tote for used oil and 275 gallon tote for used antifreeze.				
Staining/ evidence of spills:	N				
Floor drains in storage area? (Y/N)	Y				
Location of floor drains in storage area?	Shop				
Adequate spill containment? (Y/N)	Y				
If stored outside, are wastes covered? (Y/N)	N/A				
How is the waste handled/ transferred to its storage area?	Hand hauled and dumped into container				
Potential for spill to reach sanitary sewer or storm sewer? (Y/N)	N				
Waste Transporter/ Destination	Safety Clean				
Records Adequate? (Y/N)	N/A				
Evidence of improper disposal/ staining around dumpster(s)?	<input type="checkbox"/> YES <input checked="" type="checkbox"/> NO	If YES, describe:

Photo 4: Waste oil and antifreeze collection totes located in the north east corner of the shop.
